# historic structure report

## restore historic commissary building to 1897

# FORT SMITH

HISTORIC STRUCTURE REPORT  
RESTORE HISTORIC COMMISSARY BUILDING TO 1897

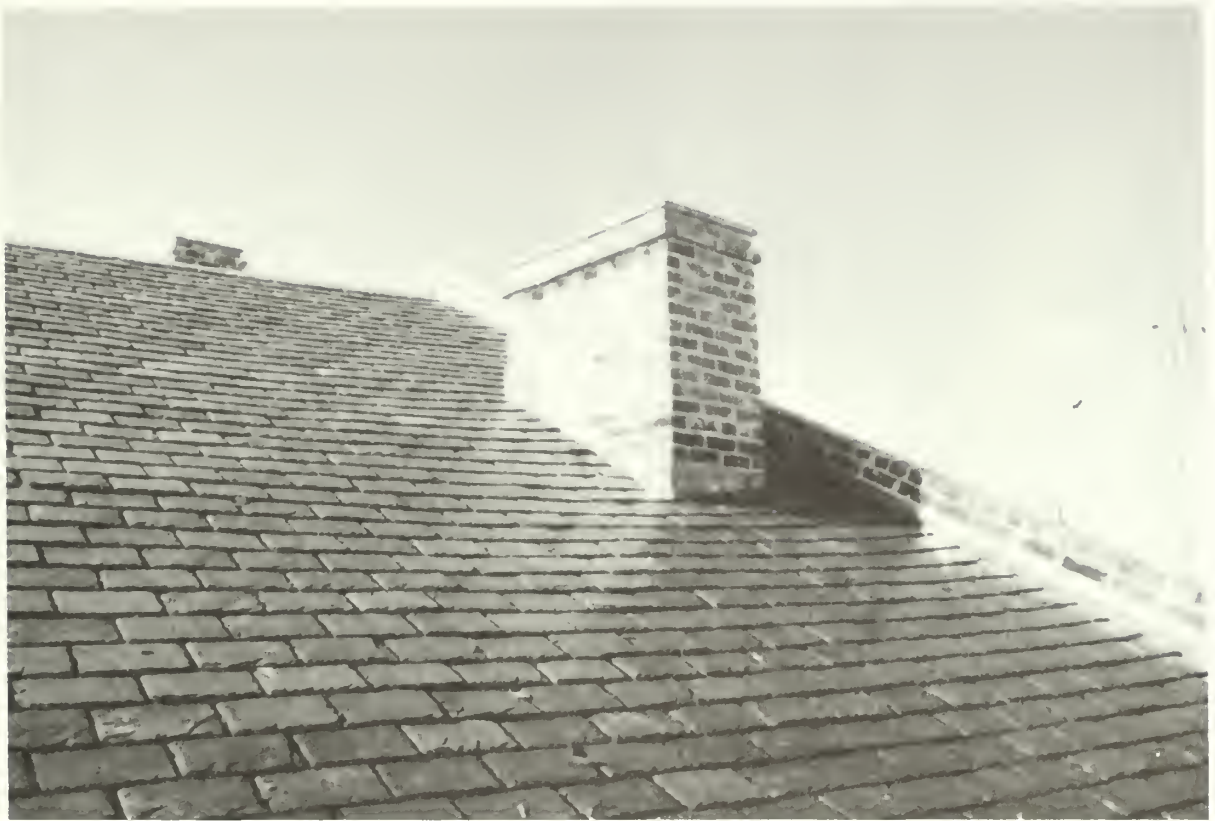
Figure 71. North Chimney (12/14/83): In this view the new slate shingle roof with copper flashing and counterflashing is in place, and the chimneys have been restored to their ca. 1897 appearance. Notice that the chimneys are fitted with slate caps and that bricks have been left out just below the cap corbel to facilitate ventilation of the entire building. By 1894 the north chimney had fallen down to the lower height shown here, compared to the south chimney which, although damaged, was fairly intact.

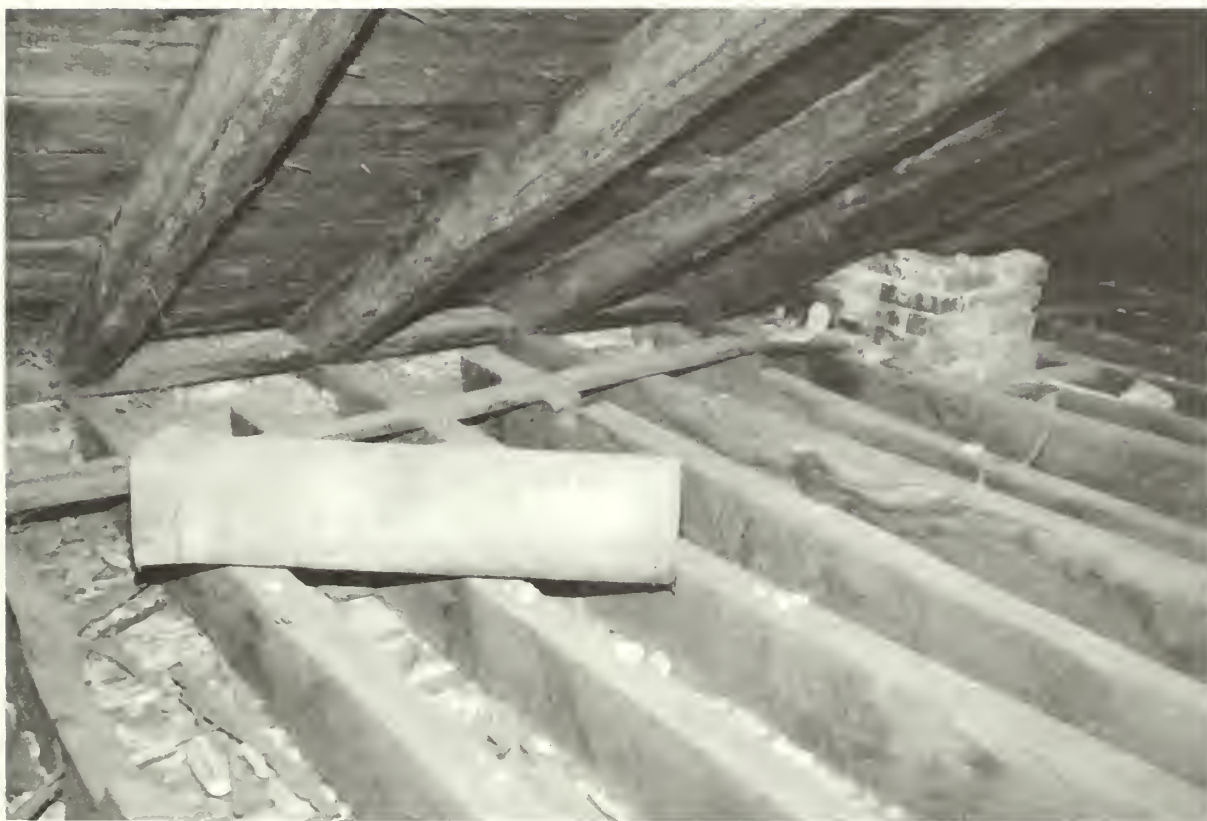
Figure 75. Attic - South Chimney (6/25/83): The original south stove chimney was built into the south stone wall. It rose beyond the wall in a simple two-brick square design which was cut off below the roof in the 1910s, or later reroofing, and before the installation of extant roof sheathing. Note both wooden and slate shingle fragments scattered near chimney as well as several bricks that were reused in the restoration.

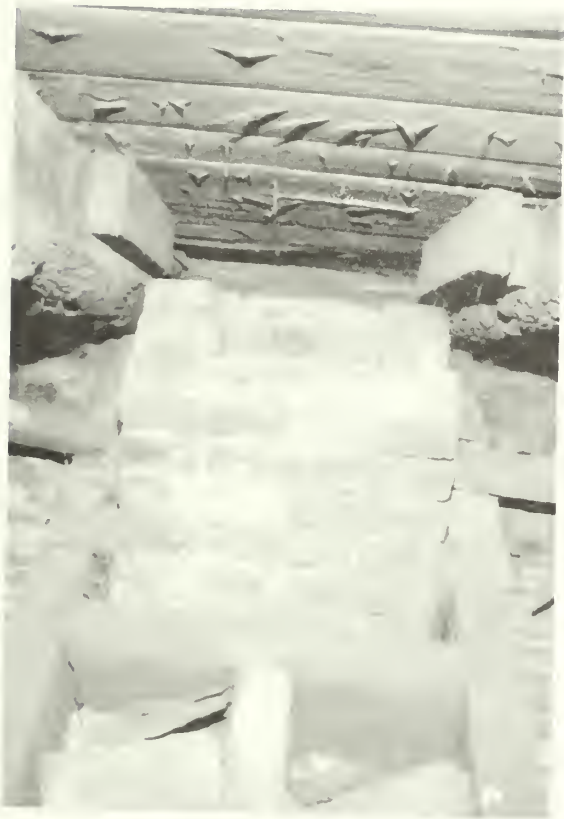
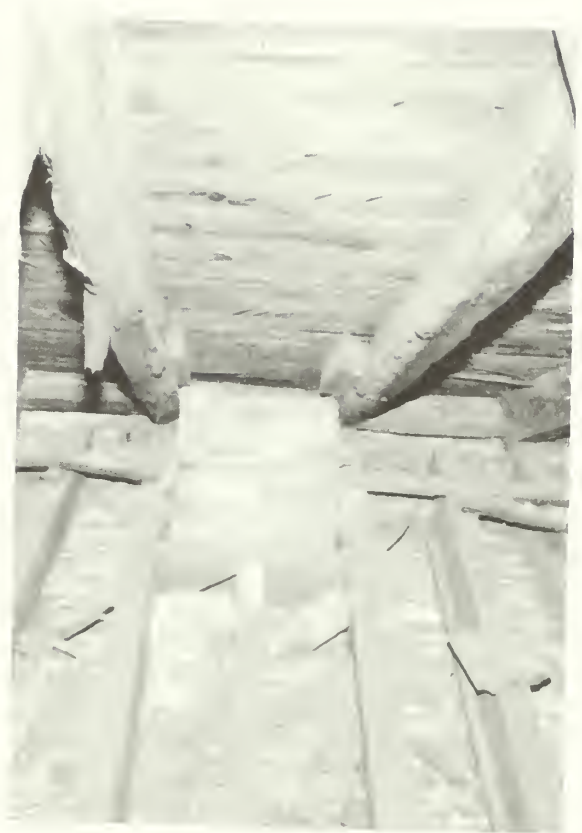
Figure 76. Attic (6/25/83): Four points are illustrated in these photographs. At the left, the large east wall shear crack is clearly visible, but more importantly, it is an old and dormant crack whitewashed historically. In the right view, the attic floor joists appear with a whitewash coating showing that the second floor had a semiopen ceiling between 1845-1866 and was whitewashed before being plastered in 1866. The variety of modern rafter bracing is shown and the need to replace it with a uniform and reliable system is apparent. The network of dead vines suggested that the growth of vines (see historical photos) was very extensive and probably caused damage to the roof system.

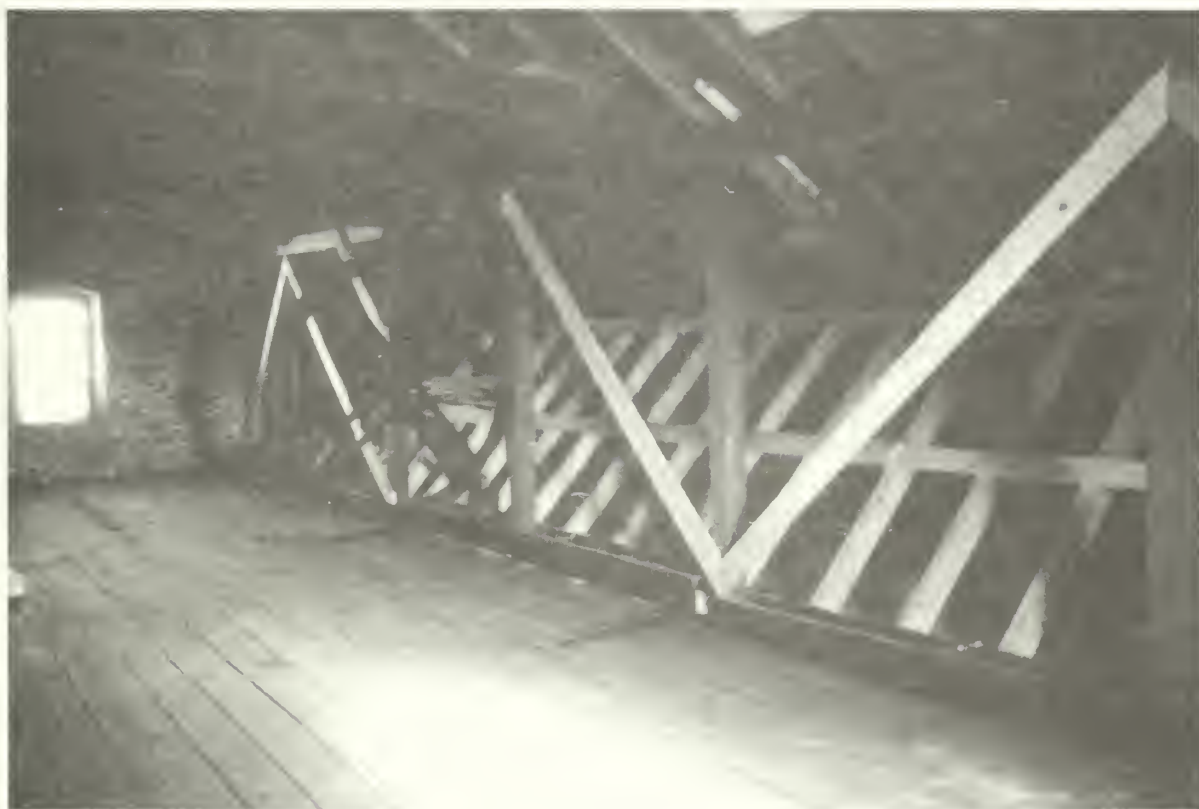
Figure 81. Attic (12/14/83): Looking towards the south corner, in this view, attic structural systems--steel beams at floor level and wooden diagonal struts and braces--have been installed. The historic flooring has been reinstalled. Note hoist cable chase (small square box) at left. Also, light-colored roof sheathing is 1983 replacement material.

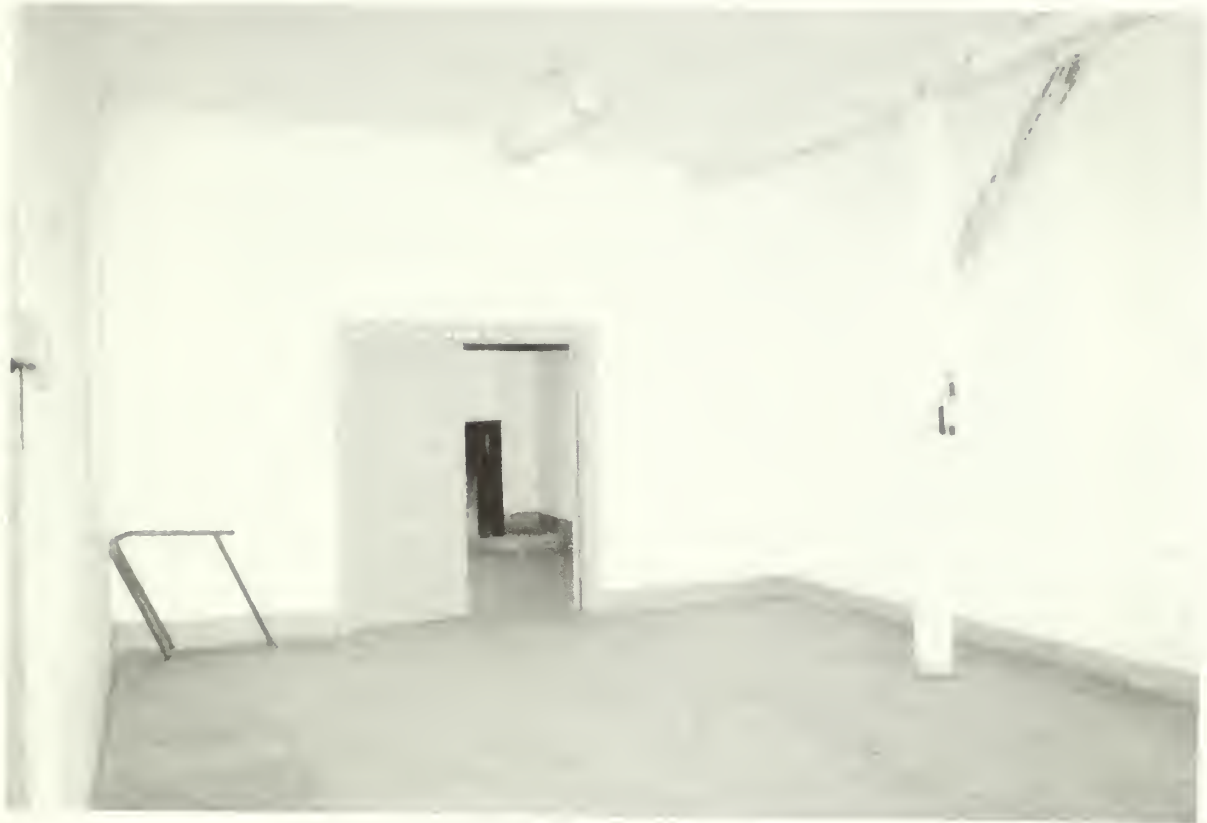
Figure 83. South Support Post - Second Floor (1/3/85): A 9x9 post was chamfered and hewn to duplicate the original support post. It was mounted directly above the post below and a 5-foot-long bolster was shaped and pegged to the beam - across the splice - above. Electrical service to this floor and the attic was affixed inconspicuously to the backside of the post: note convenience outlet junction box near floor on post.

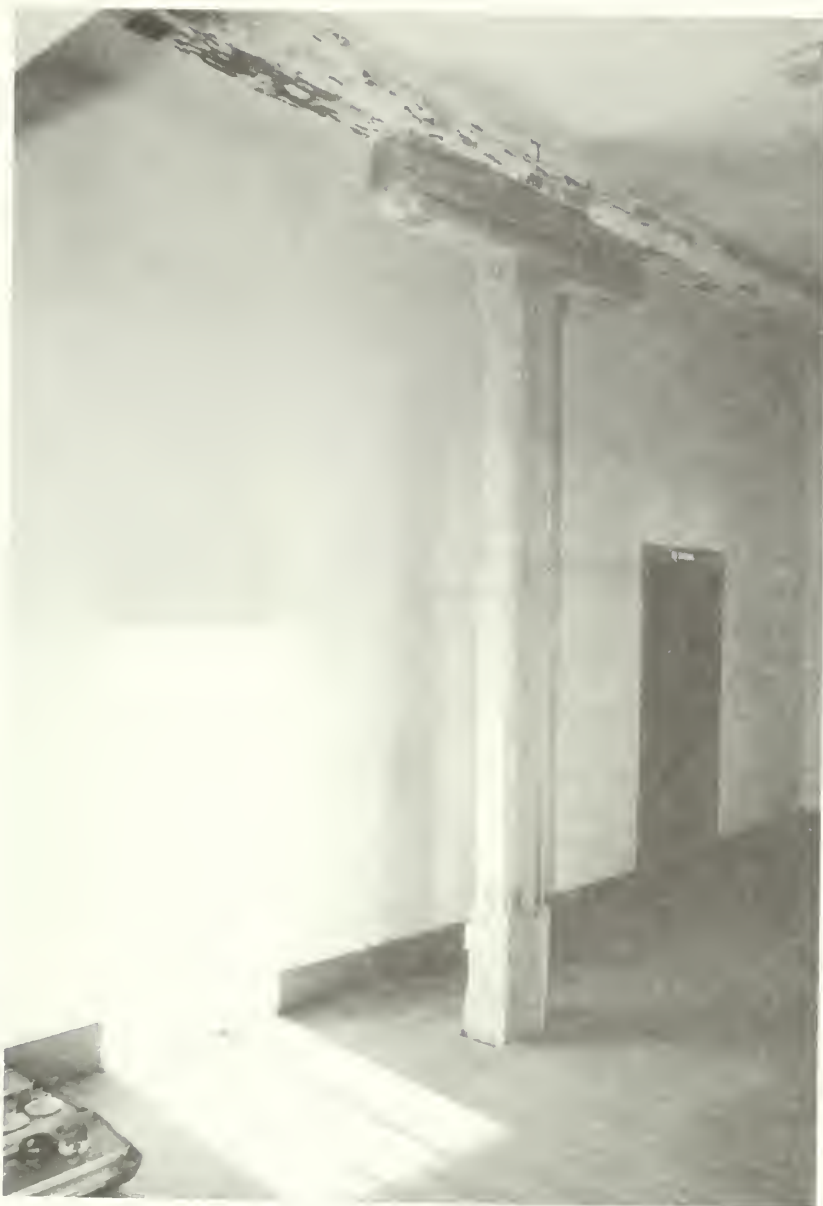
Figure 84. Reconstructed Support Post (12/14/83): The original support post at this location was removed, maybe as early as 1866; but, at least by the time the present partitions were installed. The 3" by 8" pilaster to the right was installed to replace the post function, an inadequate structural solution. The new post here duplicates size and design of posts in the north room and is hewn red oak.

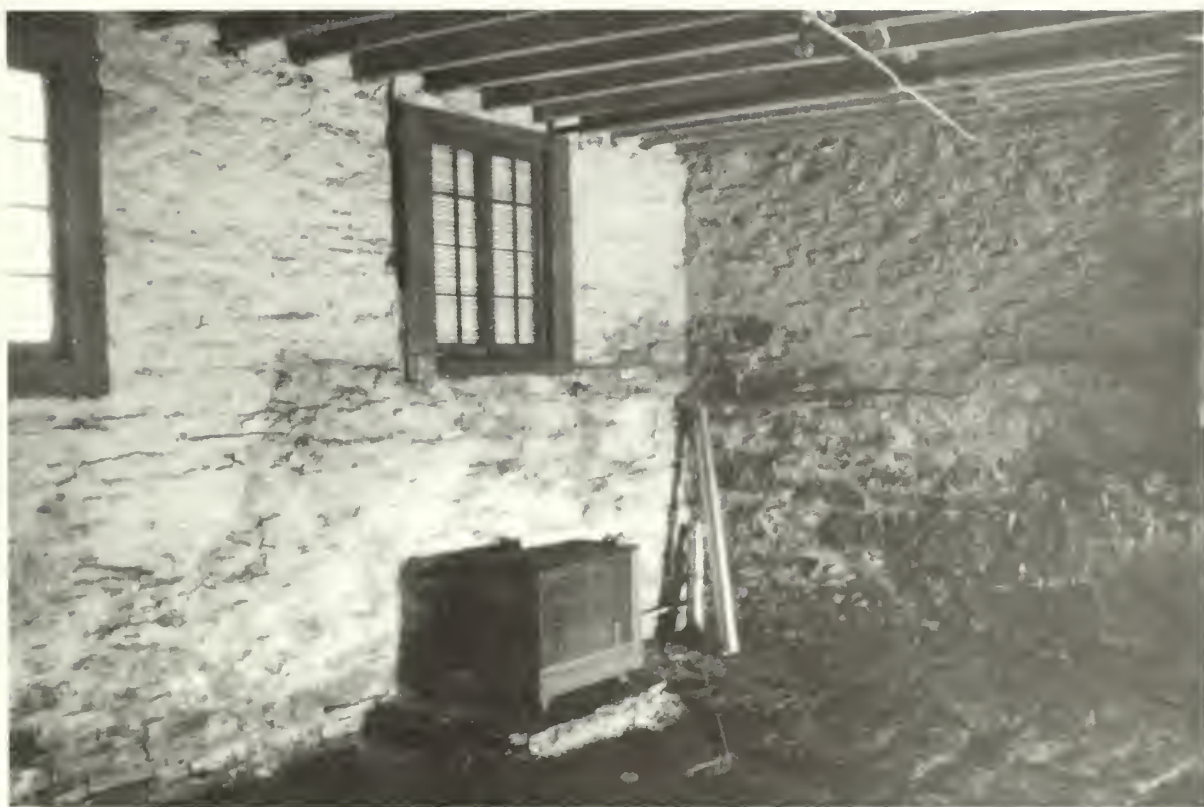
Figure 86. First-Floor Windows (1/31/84): Detail shows typical appearance of four of the six windows at the first-floor level, modified by removing glass and installing louvered panels. This was done to facilitate uninterrupted natural ventilation through the building. Significant drying of the wooden support posts took place within the first year after installation. Natural updraft through all fireplaces and chimneys is also part of the ventilation system.

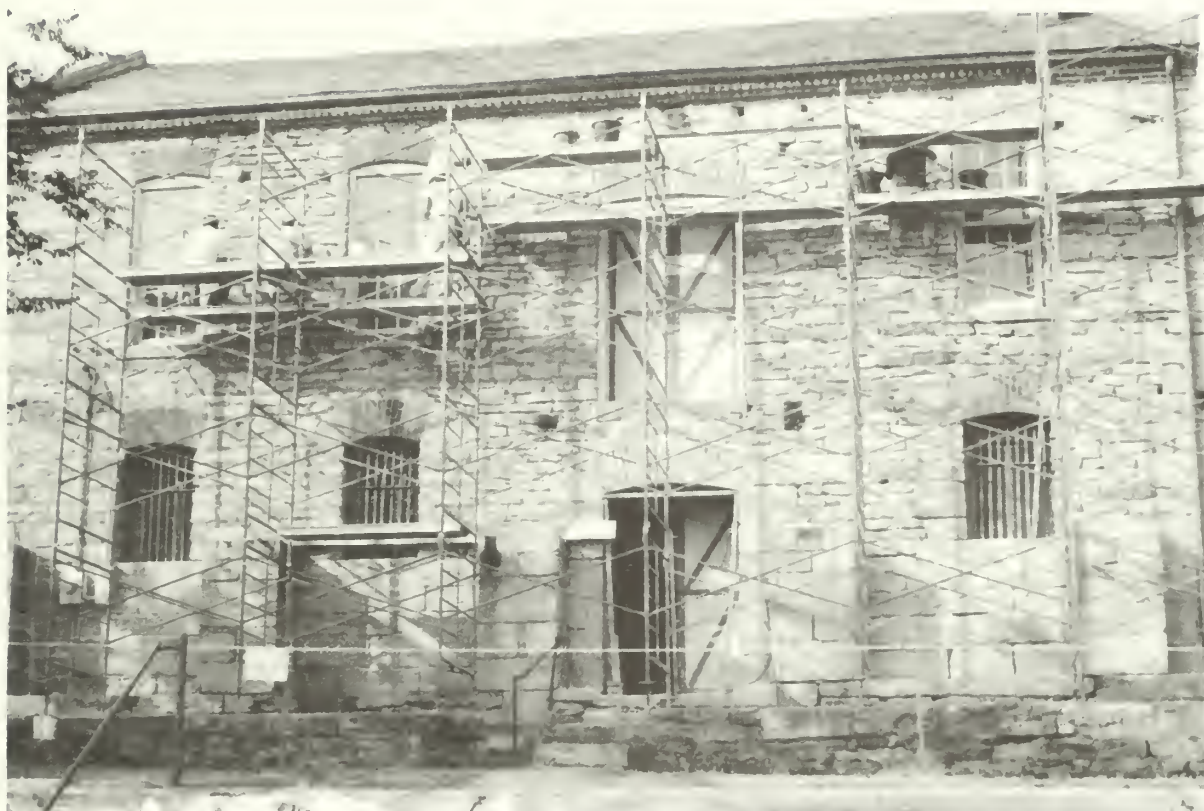
Figure 87. Repointing North Facade (8/84): First the entire facade was raked from top down. Then the wall was repointed, again from top down. In this view the north facade has been raked - clearly exposing beam pockets and wooden nailer holes - and repointing has begun at the upper level.

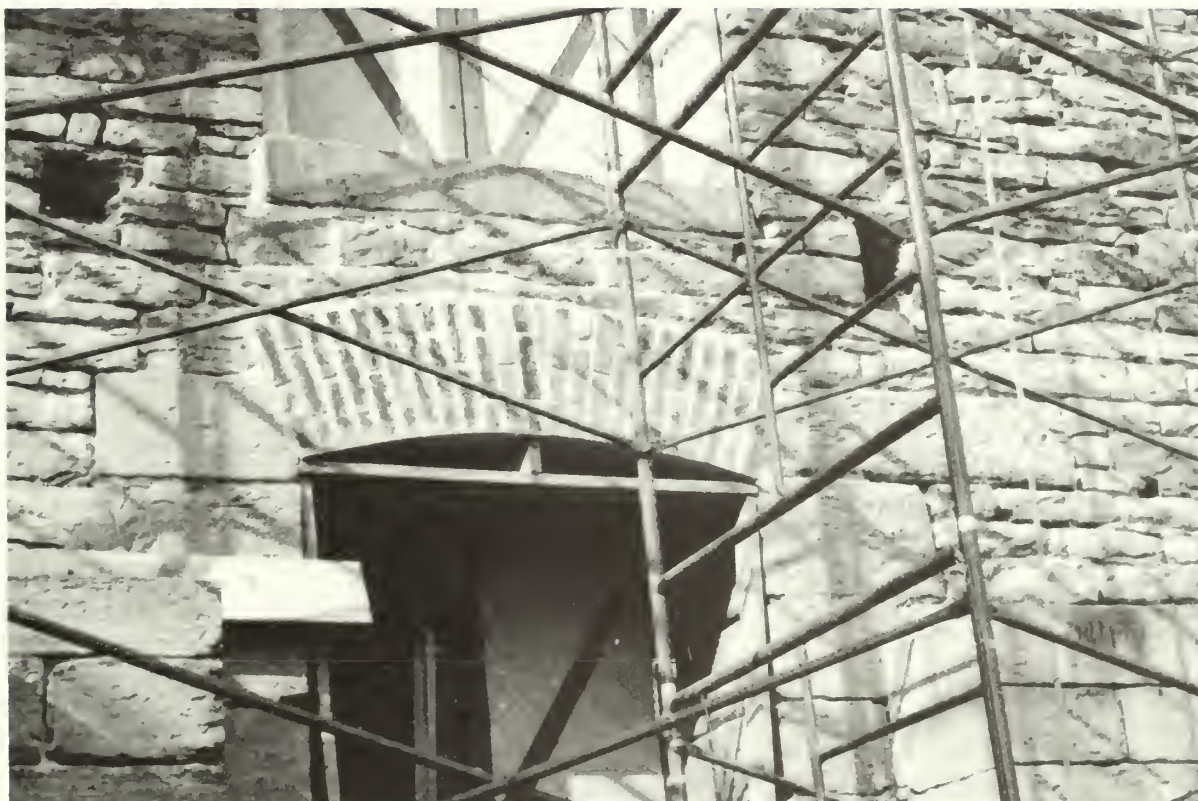
Figure 88. Detail at North Door Area (8/84): This view was taken after the raking phase of masonry treatment; the cement smear has been removed from the brick rowlock arch and beam sockets (for the second floor of porch 4).

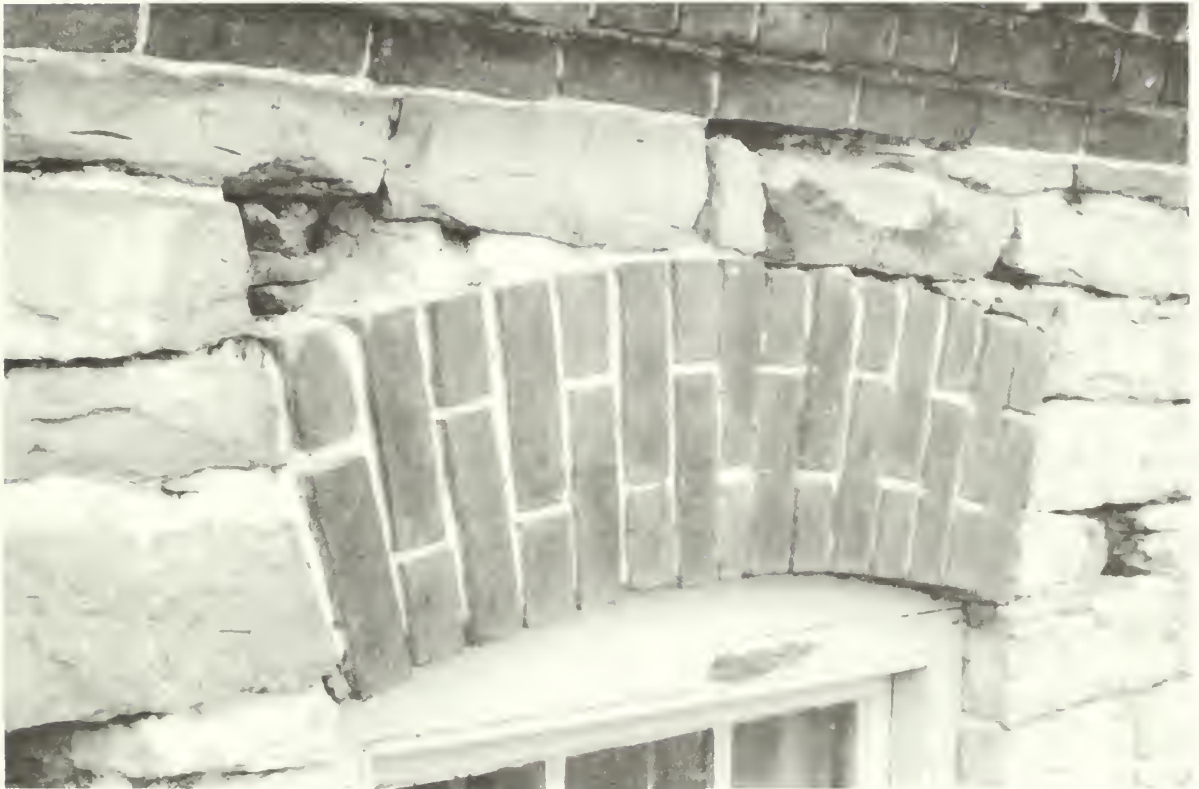
Figure 89. Detail at West Window, North Facade (8/84): In this view, raking has been completed. The texture and quality of historic masonry construction is clear. Also note pockets cut into the wall about 1866 to facilitate installation of porch 4 roof.

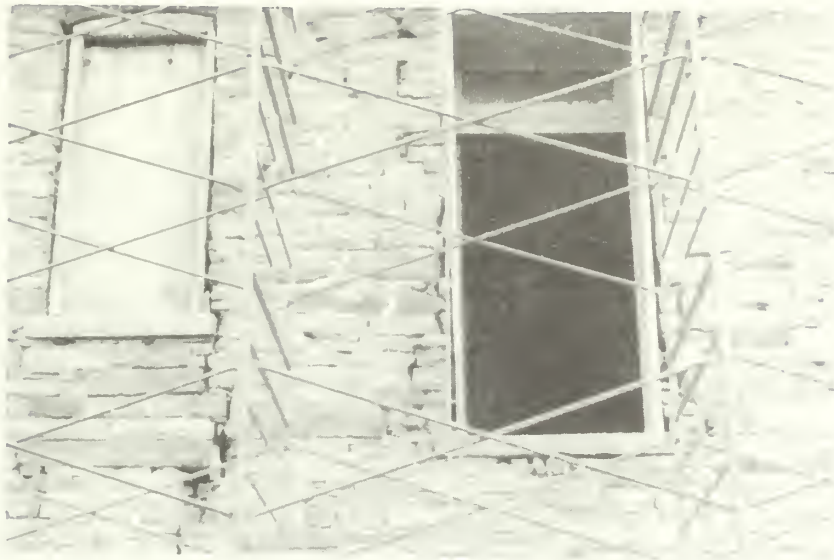
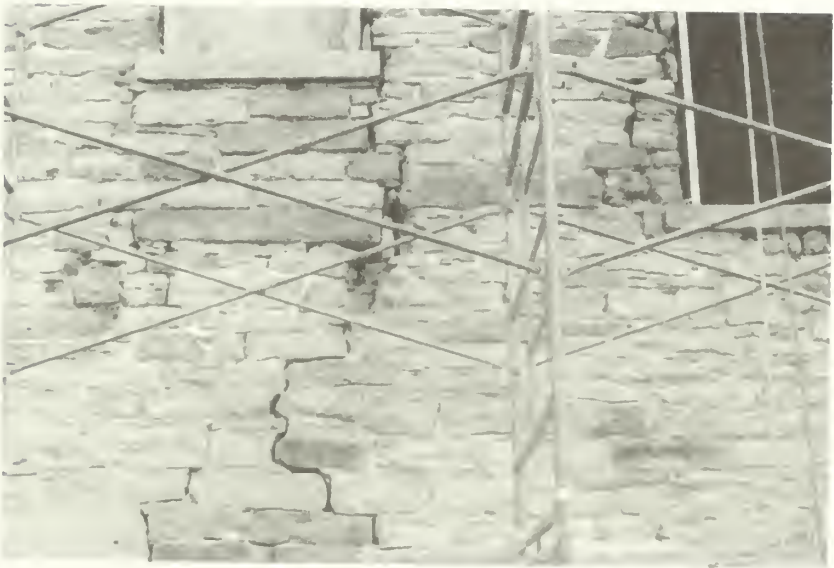
Figure 90. East Wall-Shear Crack (8/84): These photographs were taken after the removal of modern cement and loose mortar. Clearly exposed is the major shear crack that resulted from differential settlement of the south corner of the commissary.

Most likely, because the foundation of the building was built in two periods separated by seven years and because the foundations of the two periods were different, a differential subsidence naturally followed.

The subsidence probably occurred soon after construction and resulted in shear cracking of the east wall near the building's south corner and the fracture in the lower south door rowlock arch (refer to "Report Concerning the Faults Occurring in the Southeast Corner of the Commissary . . ." prepared by James M. Gaston, Jr. in Dollar, May 1983).

The general subsidence that took place years ago is not likely to result in additional damage, i.e., cracking appears to have stabilized; however, some slight differential movement between the two masses of the building resting on two different foundations is likely to occur because of fluctuations in groundwater that would naturally occur and therefore repointing would be needed periodically.

Conclusion: No problems existed requiring structural treatment. To keep the crack relatively dry, mortar should be maintained in it.

Periodic pointing like that done in 1984 will be required. The observation by Staton that "insufficient lintel strength in the south window of the east wall and lower door of the south wall" is probably inaccurate and the more likely cause was the same as that discussed about the shear crack. Both rowlock arches were restored in 1984, and future failure of a structural nature is not anticipated.

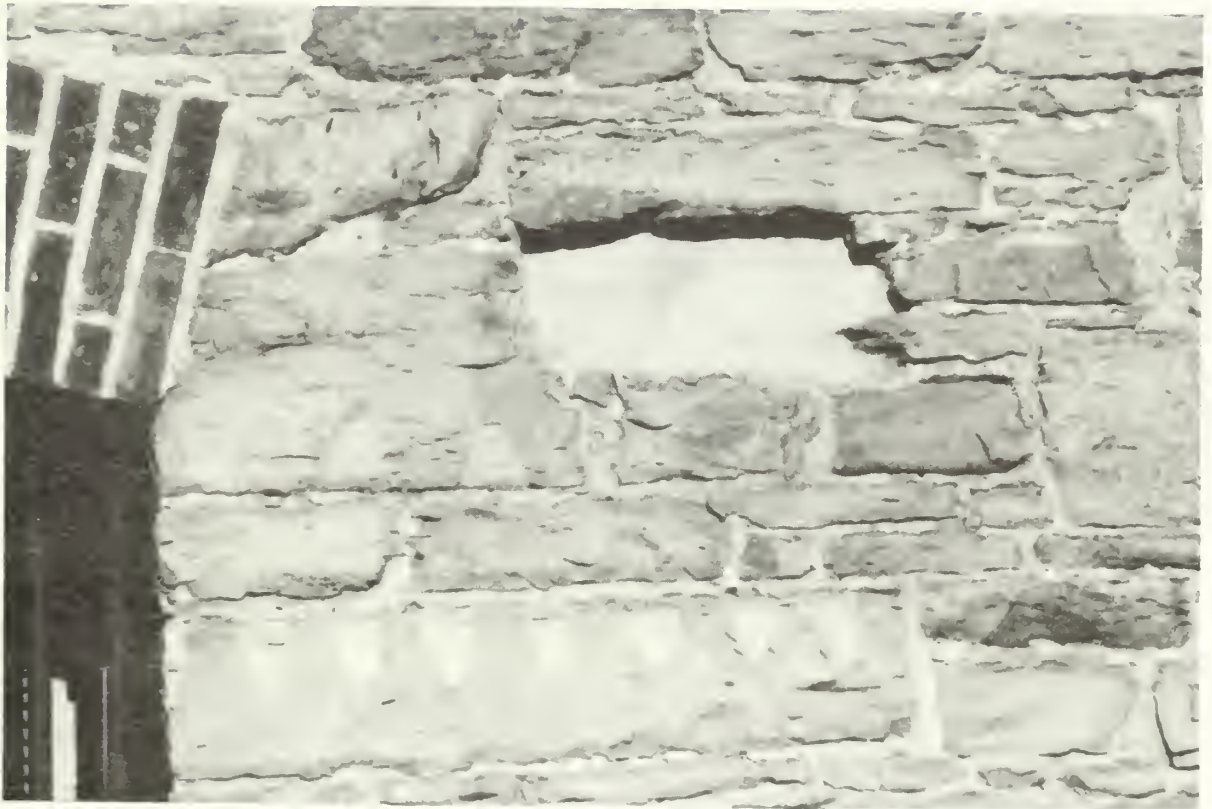
Figure 91. Wall Treatment Detail (1/3/85): In the center of the photo is a typical beam pocket after rehabilitation. Also shown are historic mortar joints and 1984 repointing that blend indistinguishably and the feather and wedge tool marks on some of the stones showing the historic stone quarrying technique employed.

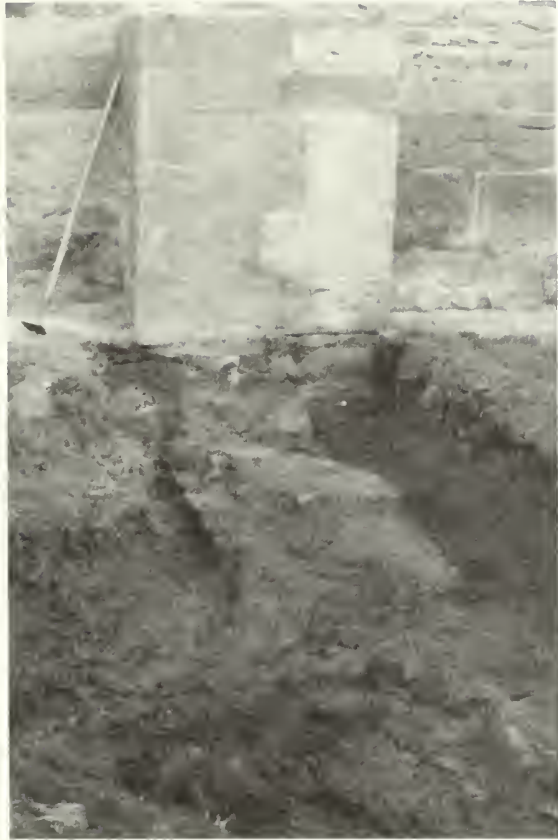
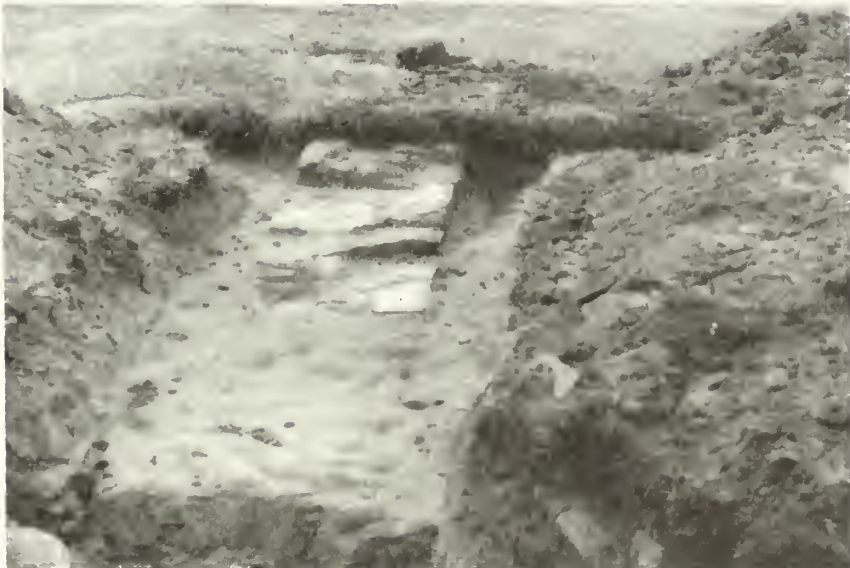
Figure 92. Fort Curtain Wall (ca. 9/8/84): Two views of extant segments of the second fort curtain wall foundation east of the commissary. The segments of wall were reconstructed on top of these footings. Where footings were absent, concrete footings were installed (see "Archeological Data" section).

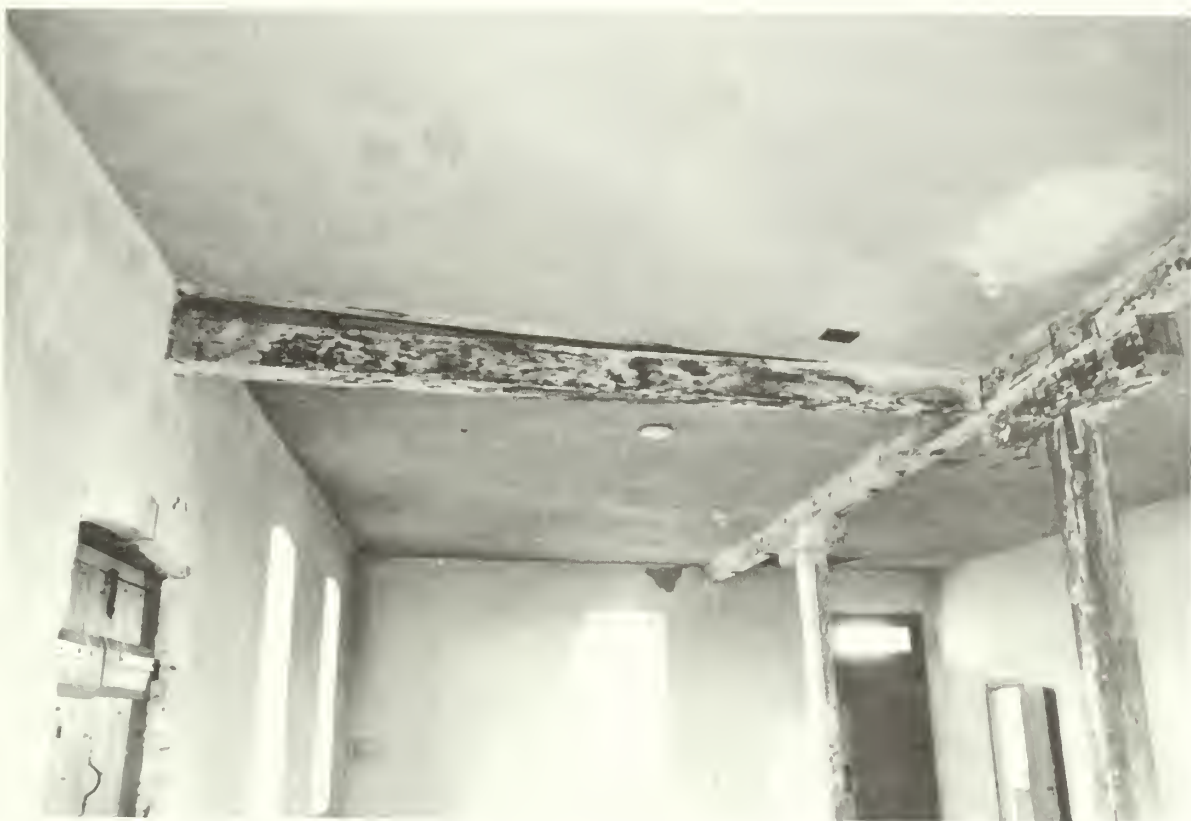
Figure 93. Second Floor (1/3/85): Very little work was performed on the second floor. The array of electrical service conduit was removed and new smoke detectors installed. Some plaster repairs were performed as shown on the upper right. Notice, also, small plates at the bottom of the transverse beam at ends of bolts that tie the beam to steel channels installed in the attic above.

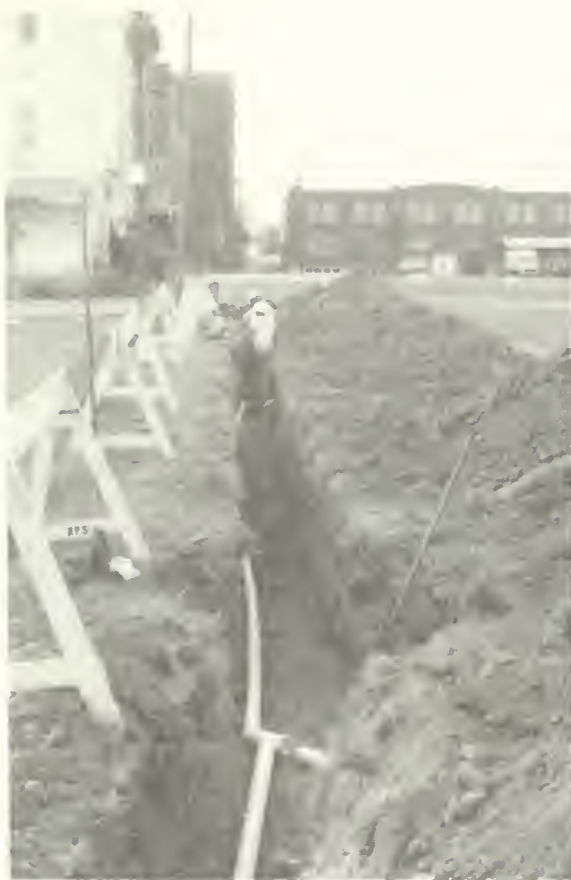
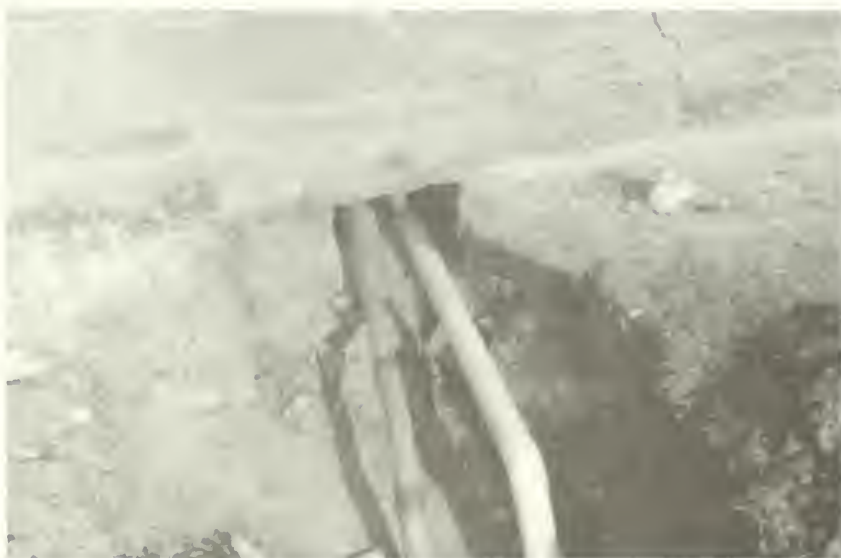
Figure 95. Underground Power and Phone Service (ca. 9/15/84): These photographs show installation of 3" telephone conduit and 2" electrical conduit from Second Street and underground to an entry below grade at the commissary foundation about 8 feet from its south corner.

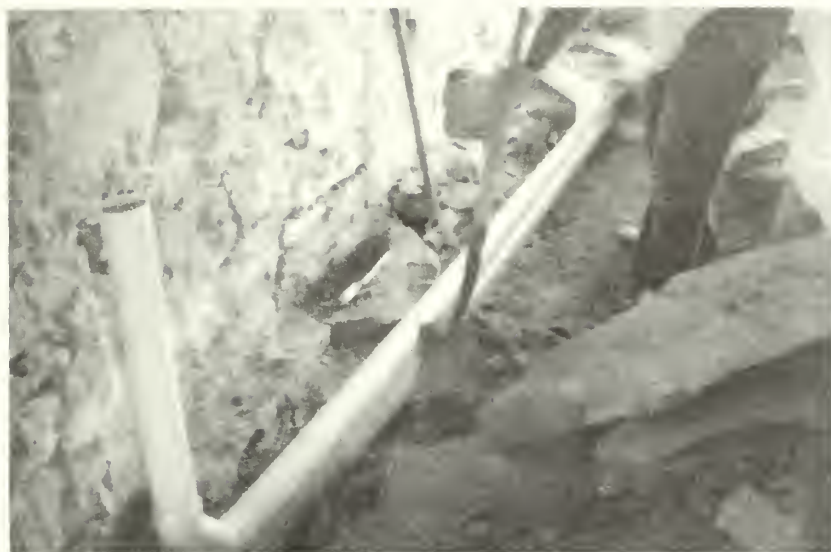
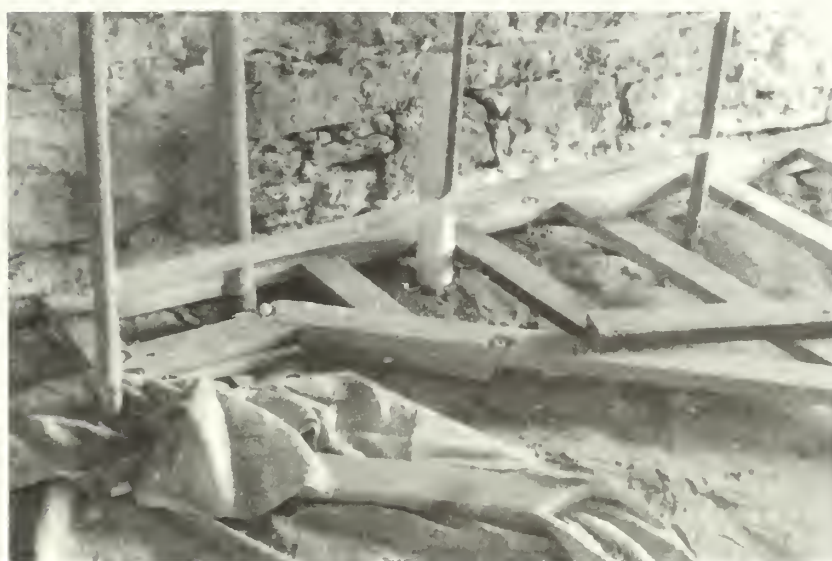
Figure 96. Power and Phone Service (9/84): These photographs show service conduits being installed below the stone slab floor at the south corner of the first floor. In the lower picture, the stone flooring is reinstalled and the sleeper-frame of the visitor platform and panel cabinet has been installed.

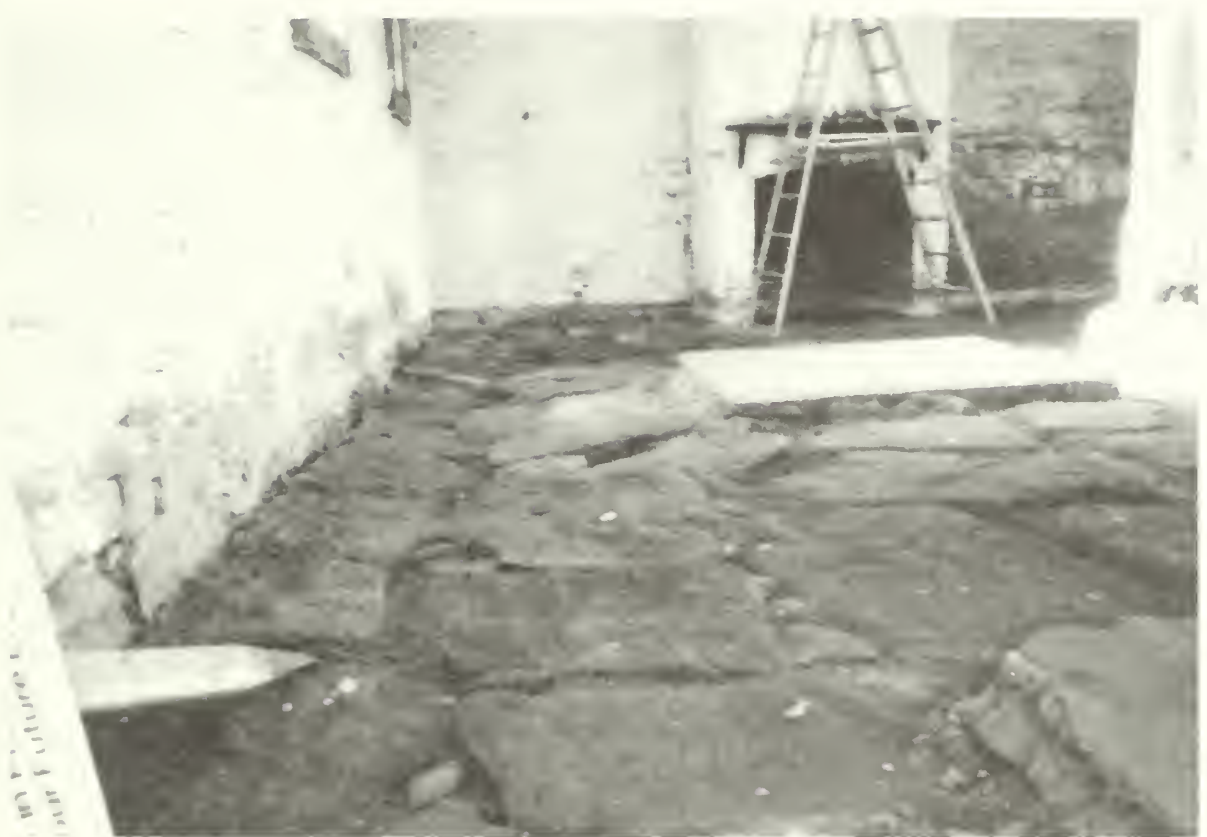
Figure 97. First Floor (12/14/83): The slump and irregularity in the historic stone slab floor became visible as the concrete was removed. The uneven surface lead to the decision not to allow visitors to pass through the room for safety reasons; but, rather, to restrict their access to a modern floored visitor platform. The "Interpretive Prospectus" (see Preface and "Administrative Data" section) supported the concept of the room as a display that could be experienced from one point, the south corner.

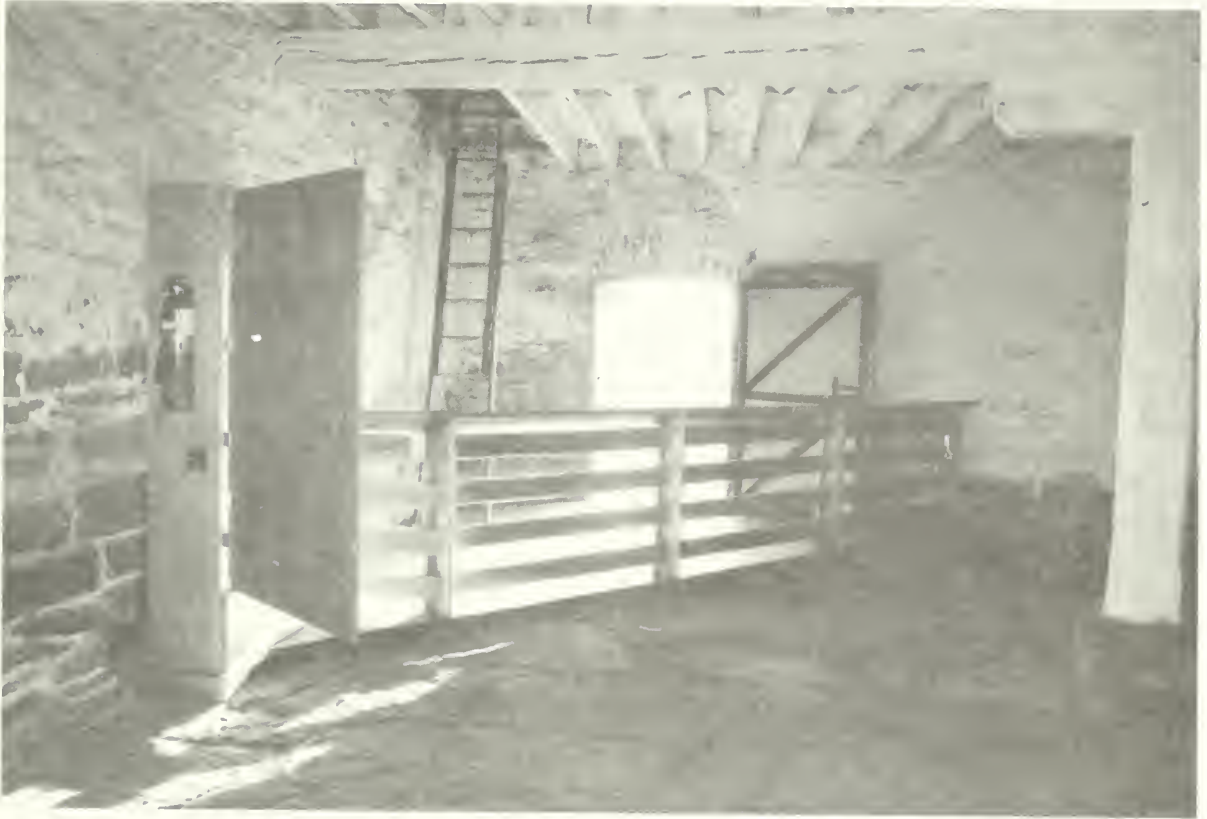
Figure 98. South Corner of First Floor (1/3/85): The visitor interpretive platform and utility core for the commissary was located in one corner: at the south entry, in place of the modern stairs and washroom. This development includes the wooden platform from which the room, as the primary display, can be viewed as well as the wooden panel cabinet (door is open) where electrical systems are controlled. The ladder will not be present during visitation. Notice, also, the restored rowlock arch and masonry above the doorway.

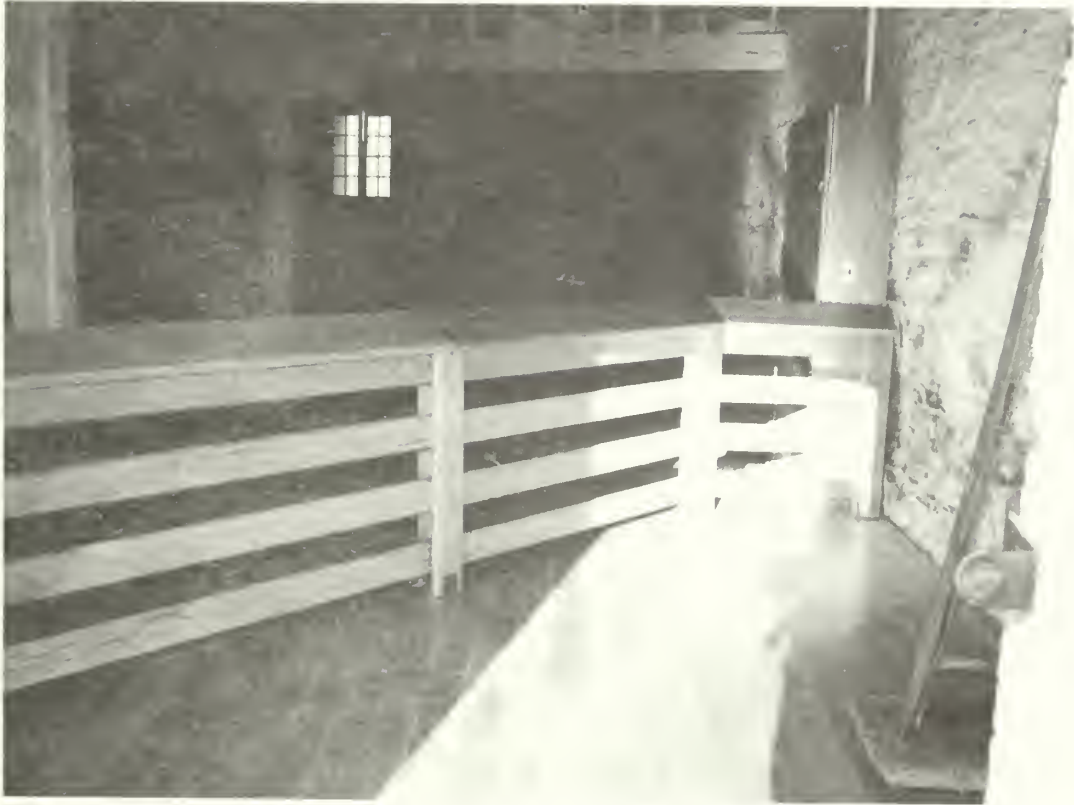
Figure 99. South Corner of First Floor (1/3/85): The visitor interpretive platform is ready to receive interpretive devices. The light switch is operated with a key. All developmental intrusions are concentrated in this corner of the building. Note, the ladder at right will not be present during visitation.

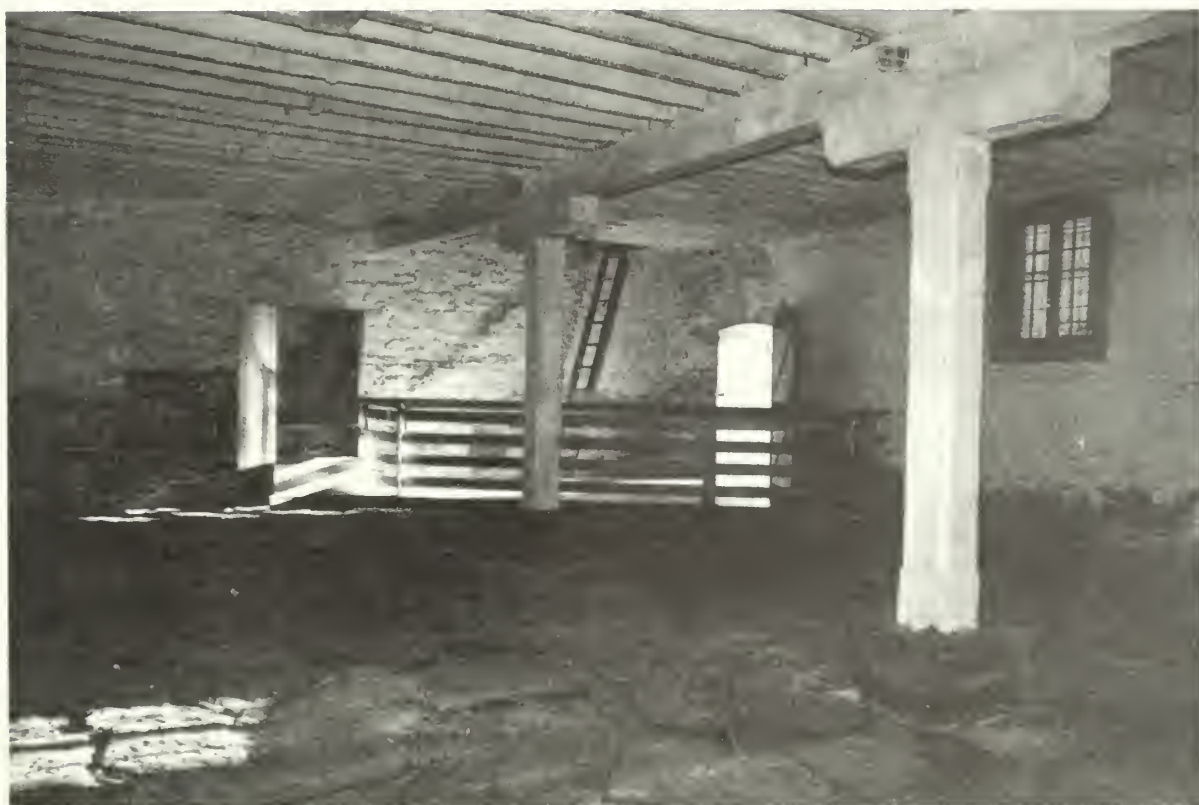
Figure 100. First Floor (1/3/85): This view shows the visitor platform as seen from the restored commissary storeroom - the stone slab floor, repaired and whitewashed support posts, and whitewashed ceiling system are shown. Notice the electrical conduit and light fixtures are placed so as to be imperceivable from the point of view of the visitor platform.

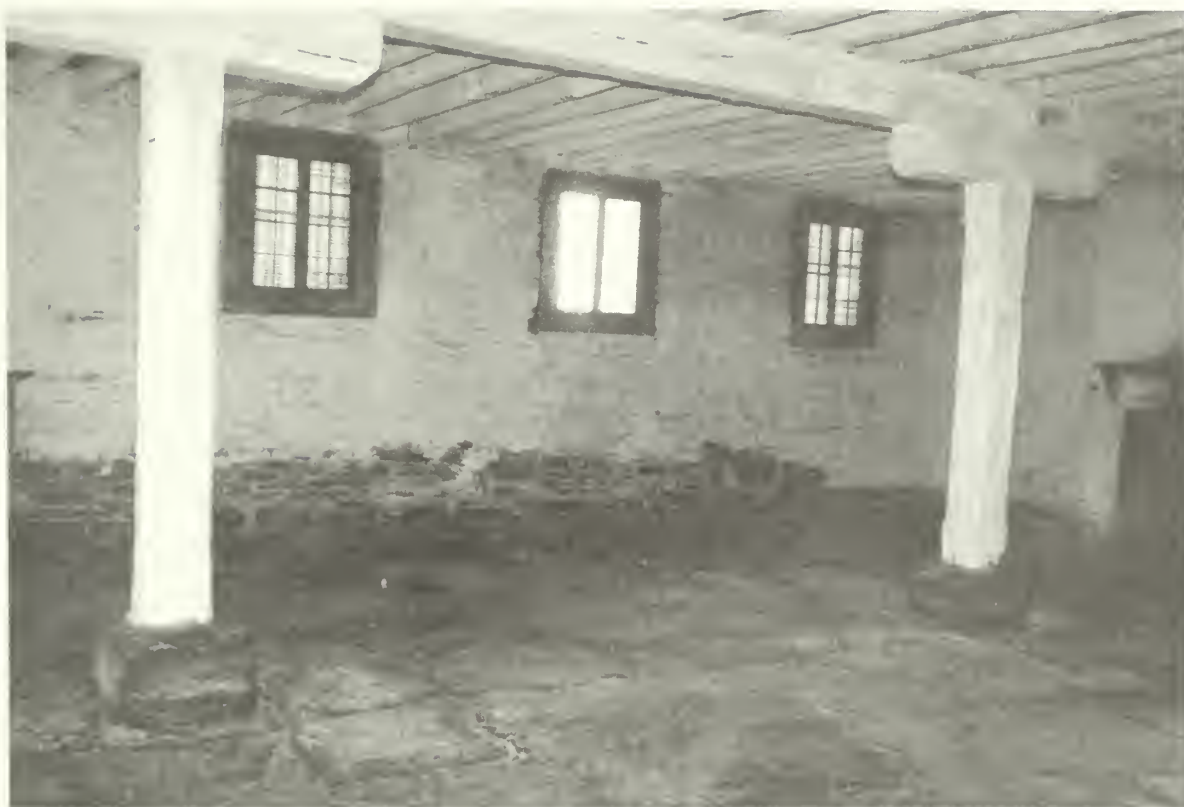
Figure 101. First Floor (1/3/85): Another general view of the restored first-floor room looking towards the south wall. Two windows received the louvered panel modification. The lower wall area was raked and repointed, but walls should not be whitewashed to avoid covering historic ghosts.
